Earthquake Risk Management: Failures of Modern Buildings in the 2023 Turkey-Syria Earthquakes

Anas Alzenbrakji^{1*}

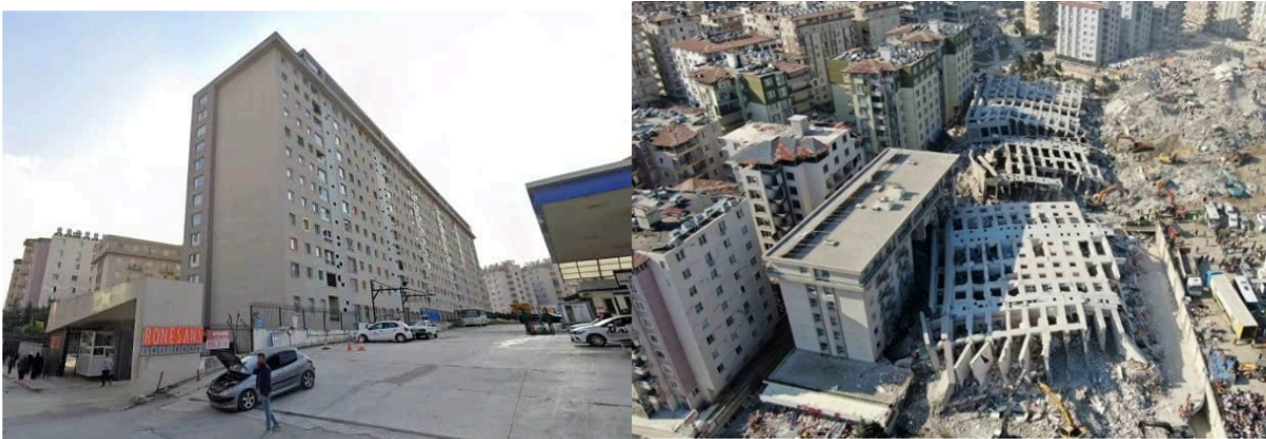
Figure 1. Rönesans Rezidans Before and After the Earthquake Collapse.

Collapse Details: A 12-story luxury apartment complex, fully collapsed during the Mw 7.8 quake, killing hundreds. The building housed approximately 250 apartments and had commercial units on the ground floor [1].

- ❖ Inadequate column reinforcement and insufficient confinement.
- ❖ Use of substandard materials, including low-strength concrete.
- ❖ Soft-story ground floor due to commercial use.
- ❖ Possible unauthorized structural modifications

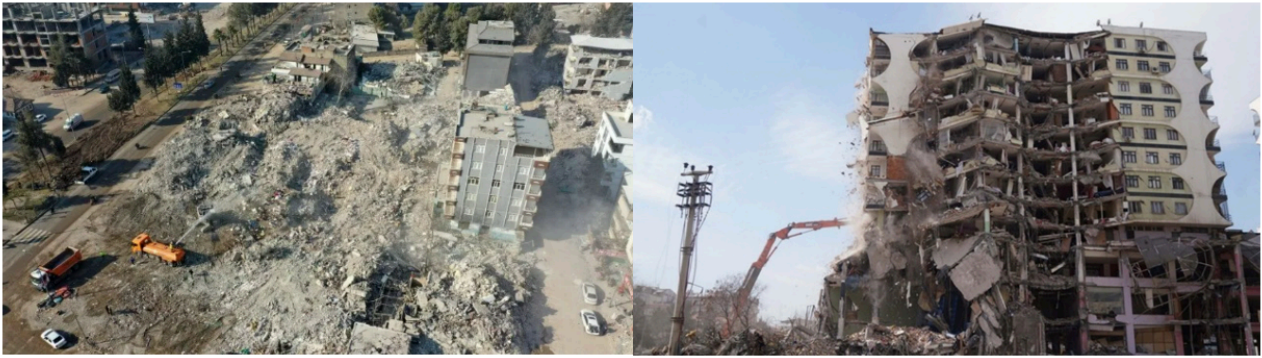
Figure 2. Galeria Sitesi Before and After the Earthquake Collapse.

Collapse Details: A mixed-use commercial-residential complex from the 1990s, collapsed instantly during the earthquake. It was one of the deadliest collapses in Adiyaman, trapping dozens inside [2].

- ❖ Brittle column failure, inadequate rebar, and outdated foundation system.
- ❖ No retrofitting done despite known seismic risk.

Soft-story vulnerability [3].

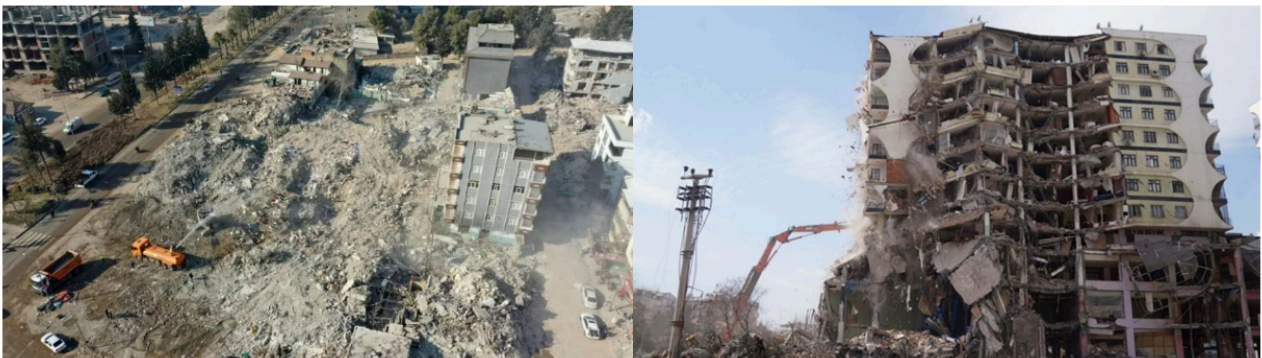
Figure 3. Isias Hotel Before and After the Earthquake Collapse.

Collapse Details: Originally a residential building (1991), converted into a hotel without proper permits. Collapsed fully, killing 35 volleyball team members, all of whom perished. The collapse was total and sudden, indicating a critical structural failure likely intensified by prior unauthorized structural modifications [4].

- ❖ Use of river sand in concrete.
- ❖ Removal of load-bearing columns for a subterranean garage.
- ❖ Added floors without permits or structural reinforcement.
- ❖ Soft-story condition due to commercial ground level.

Post-earthquake investigations revealed forged inspection records, unauthorized structural changes, and use of illegal construction materials (e.g., river sand at Isias Hotel). In many cases, floors were added without permits or supporting redesigns.
