Aesthetic Evaluations of Forest Road Templates

Abstract

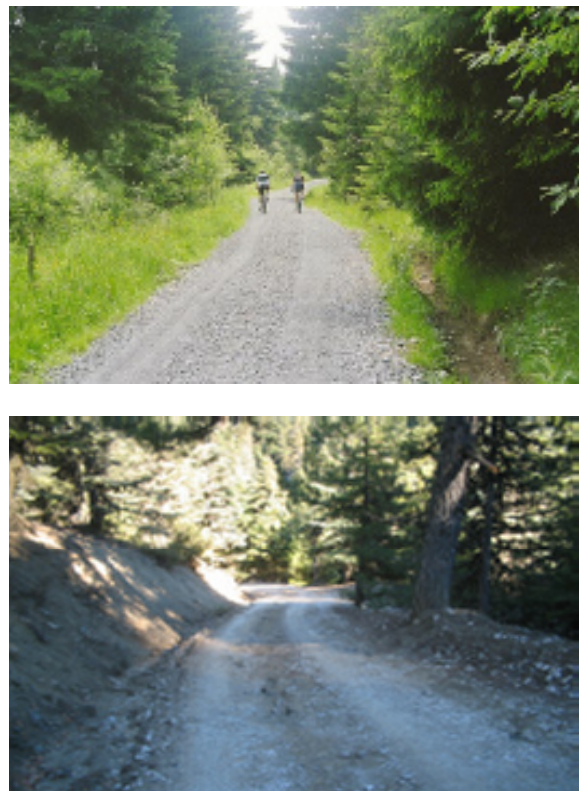
Figure 2. Two examples of warm up images indicating good (left) and poor (right) road templates regarding visual quality.

In aesthetic evaluation of the forest road images, 60 senior forestry students ageing from 21 to 24 were surveyed. Firstly, the students were informed that it was aimed to evaluate the visual quality of the four specific road components including road surface, cut slope, fill slope, and roadside condition. Secondly, 8 warm up images were presented to define good and poor examples for each component. Figure 2 shows two examples of warm up images indicating good (left) and poor (right) road templates regarding visual quality. Then, selected forest road images were presented and the students were asked to assign a score from 1 to 5 (1 = very low, 2 = low, 3 = normal, 4 = high, and 5 = very high visual quality) for each component based on their personal sense of aesthetic quality. Total numbers of 114 images were presented to the student for 20 seconds each. The students were provided with a survey sheet in aesthetic evaluation process.
